**SEDIMENT REDISTRIBUTION IN THE UILKRAALS ESTUARY AS A
CONSEQUENCE OF HUMAN DISTURBANCE**

A research report submitted in partial fulfilment of the
requirements for the degree of Master of Science in the
Department of Environmental and Geographical Science

University of Cape Town

September 1988

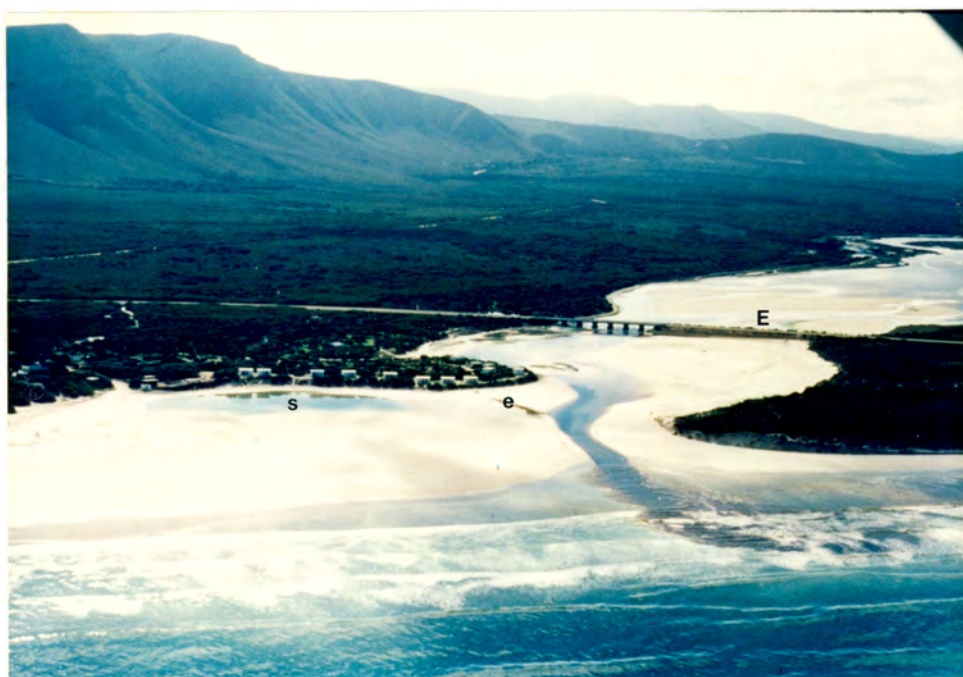
PLATE 1 OBLIQUE AERIAL VIEW OF THE UILKRAALS ESTUARY. THE BRIDGE AND EMBANKMENT (E) CAN BE SEEN IN THE MIDDLE DISTANCE. THE STAGNANT POOL (S) AND THE FIRST TEMPORARY EMBANKMENT (e) CAN BE SEEN IN FRONT OF THE HOLIDAY BUNGALOWS (ECRU, 15/8/1979).

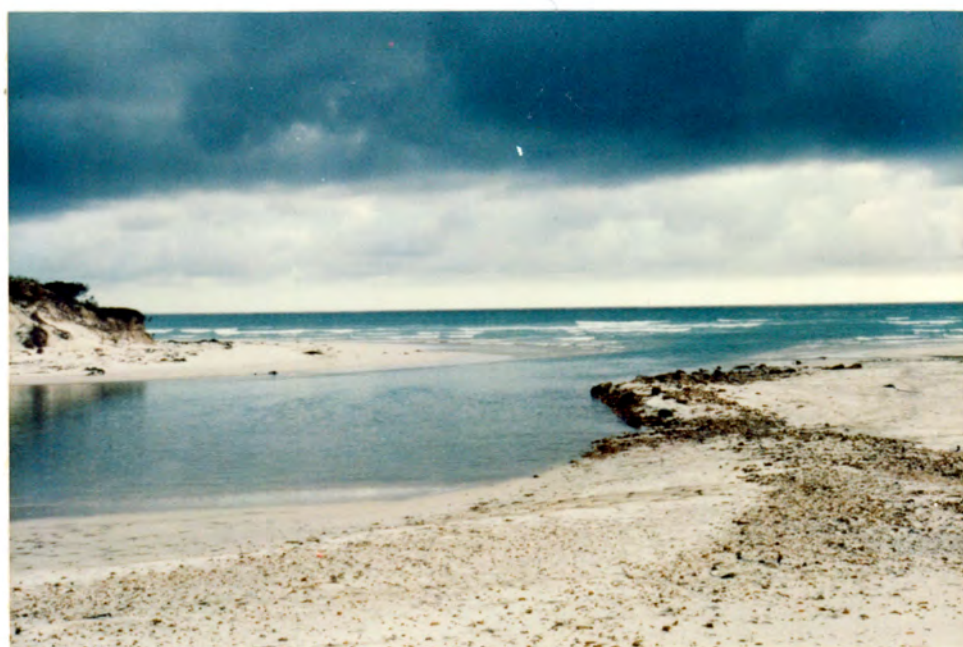
PLATE 2 REMAINS OF THE FIRST TEMPORARY EMBANKMENT. THE PHOTOGRAPH WAS TAKEN IN FRONT OF THE HOLIDAY BUNGALOWS ON THE RIGHT BANK (ECRU, 7/12/1979).

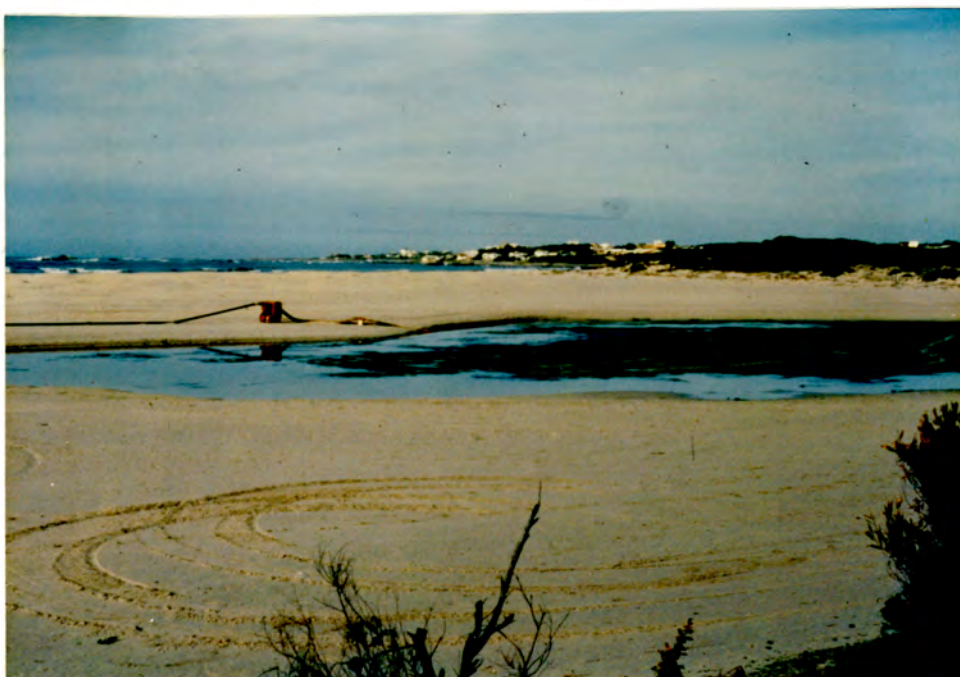
PLATE 3 STAGNANT POOL WITH ALGAL GROWTH. THE PHOTOGRAPH IS TAKEN FROM THE HOLIDAY BUNGALOWS LOOKING TOWARDS FRANSKRAAL (ECRU, 7/12/1979).

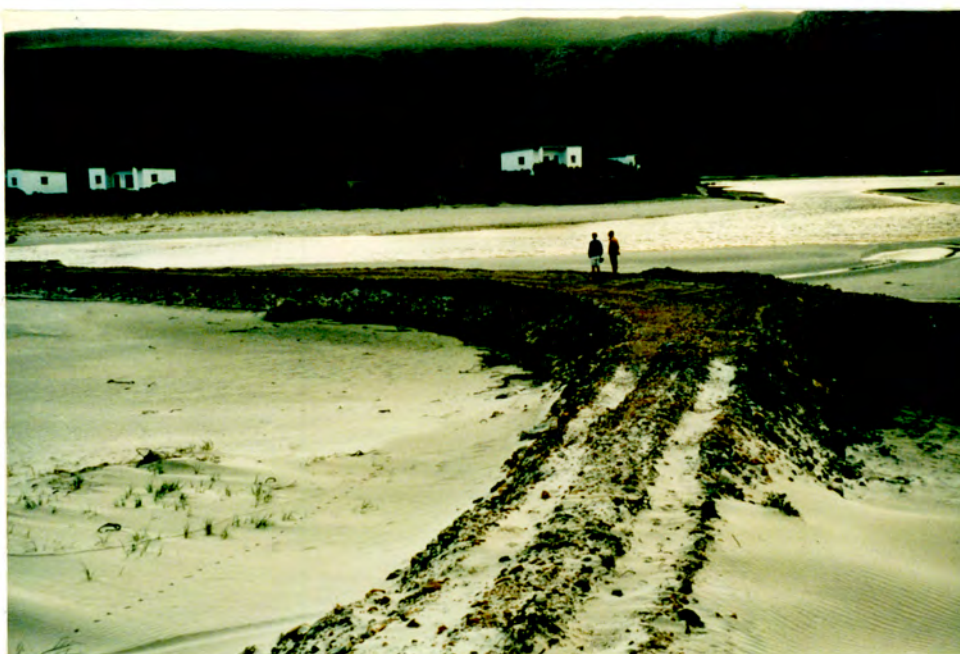
PLATE 4 SECOND TEMPORARY EMBANKMENT. THE VIEW IS FROM THE LEFT BANK LOOKING TOWARDS THE HOLIDAY BUNGALOWS (ECRU, 16/7/1980).

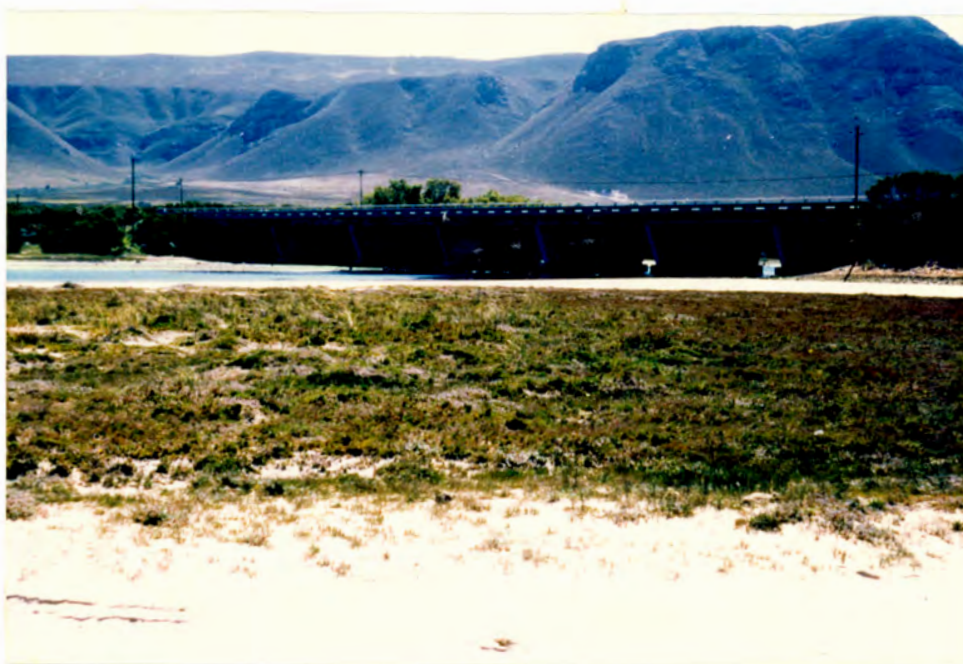
PLATE 5 NEW VEGETATED SAND AREA WITH THE BRIDGE IN THE BACKGROUND. THE PHOTOGRAPH IS TAKEN LOOKING FROM THE LEFT BANK (17/9/1987).

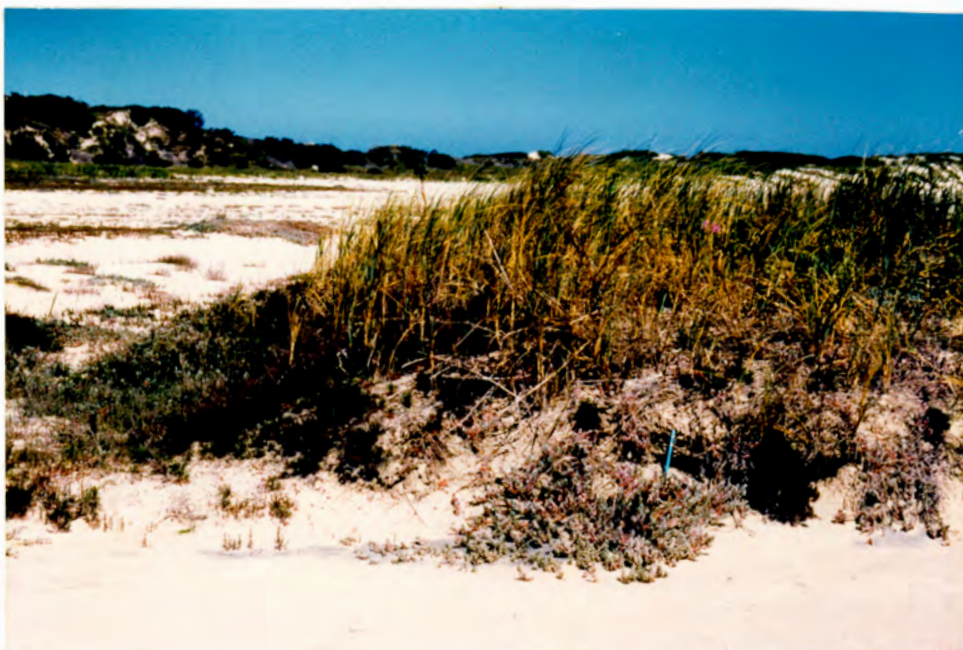
PLATE 6 SMALL DUNE ON NEW VEGETATED AREA. THE DUNE IS APPROXIMATELY 0,7 M ABOVE THE SURROUNDING AREA (17/9/1987).
